INDOOR AIR QUALITY ASSESSMENT

**Marsh Grammar School
309 Pelham Street
Methuen, MA 01844**

Prepared by:
Massachusetts Department of Public Health
Center for Environmental Health
Emergency Response/Indoor Air Quality Program
March 2007

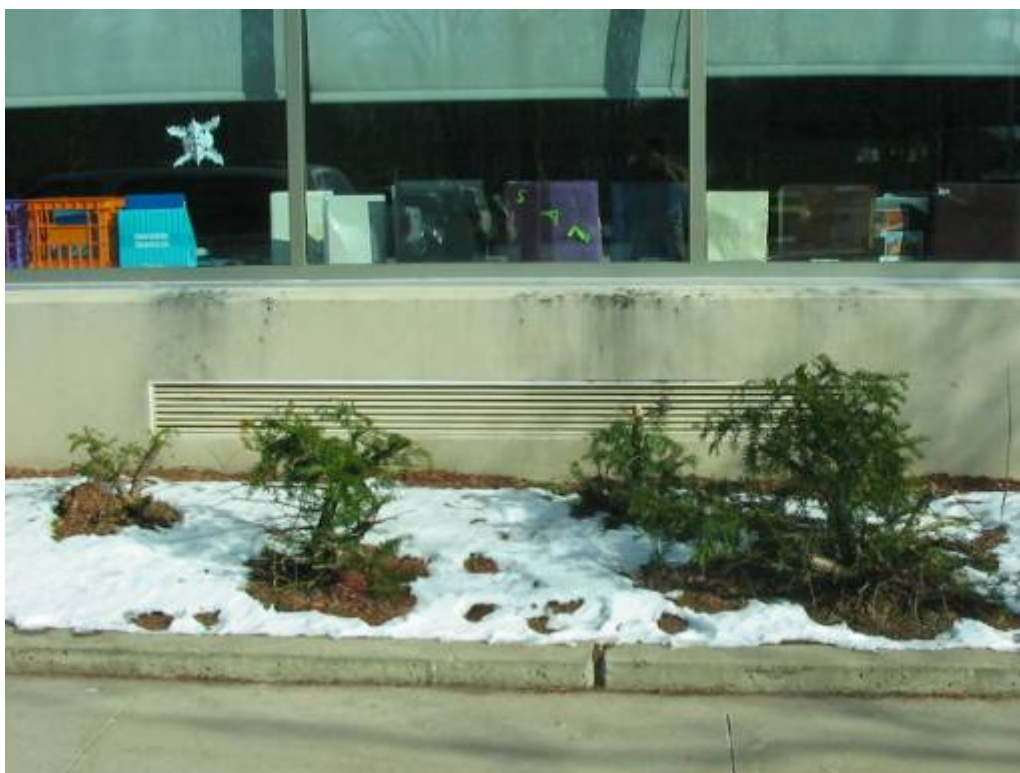
Picture 1

It can be seen from Table 1 that carbon dioxide levels were elevated above 800 parts per million (ppm) in 11 of 63 areas surveyed, indicating adequate air exchange in most areas surveyed on the day of the assessment. Fresh air in classrooms is supplied by computerized unit ventilator (univent) systems. A univent draws air from the outdoors through a fresh air intake located on the exterior wall of the building (Picture 1) and returns air through an air intake located at the base of the unit ([Figure 1](#)). Fresh and return air are mixed, filtered, heated/cooled and provided to classrooms through an air diffuser located in the top of the unit.

Univent Fresh Air on Building Exterior

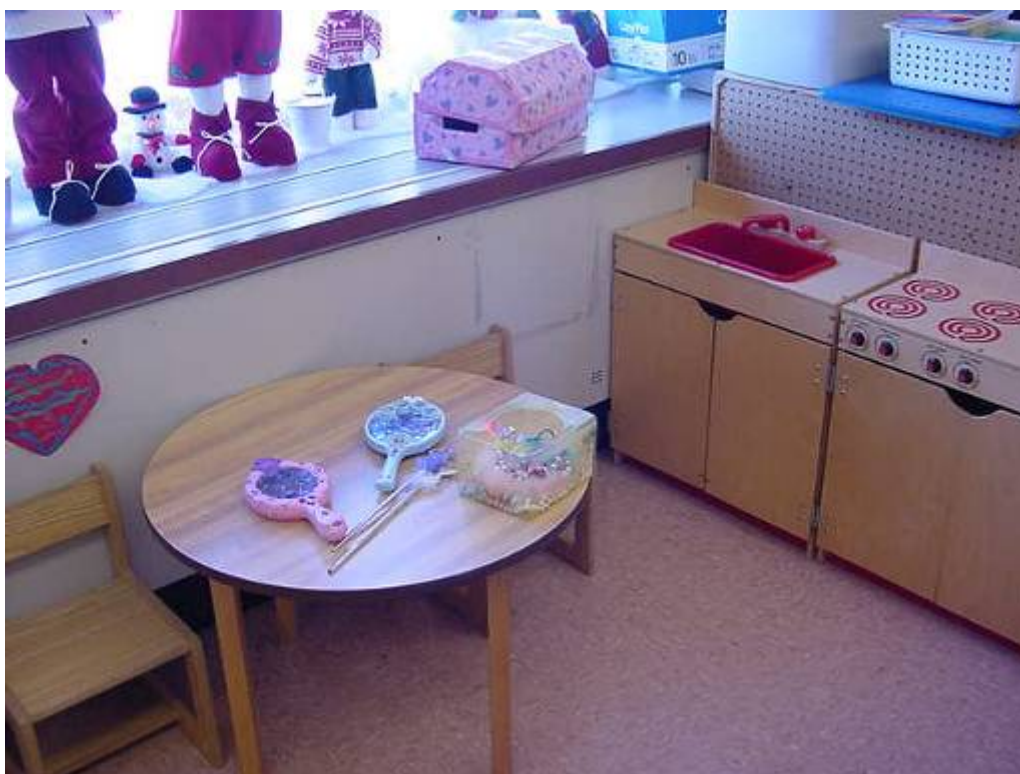
Picture 2

The majority of univents were operating during the assessment. Two classroom univents were deactivated, reportedly due to overheating. Obstructions to airflow, such as papers and books stored on univents and items placed in front of univent returns, were seen in a number of classrooms (Picture 2). In order for univents to provide fresh air as designed, these units must be activated and allowed to operate while rooms are occupied. Univent return vents and diffusers must also remain free of obstructions.

Classroom Univent, Note Furniture Partially Obstructing Return Vent (along Bottom Front)

4. Remove all obstructions from univents to facilitate airflow.
5. Ensure classroom doors are closed to improve air exchange.
6. Use openable windows in conjunction with mechanical ventilation to introduce fresh air. Care should be taken to ensure windows are properly closed at night and weekends during winter months to avoid the freezing of pipes and potential flooding.

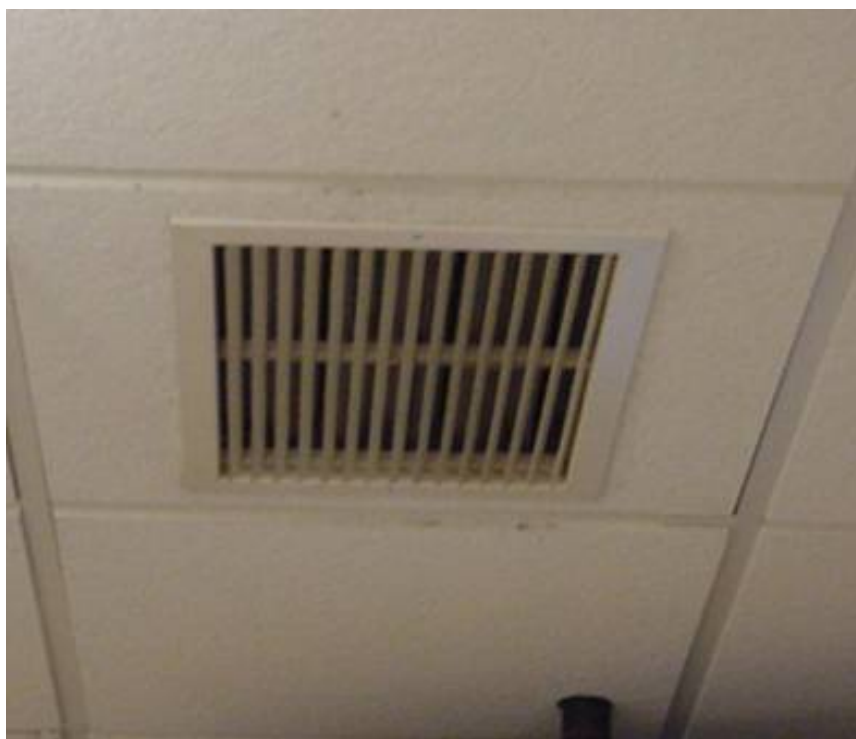
Picture 3

Exhaust ventilation is provided by ceiling-mounted vents ducted to rooftop motors (Pictures 3 and 4). Exhaust vents were operating in all but one area (room 101) surveyed during the assessment (Table 1). In some areas, exhaust vents are located above classroom doors (Picture 5). When a classroom door is open, exhaust vents will tend to draw air from both the hallway and the classroom. The open hallway door reduces the effectiveness of the exhaust vent to remove common environmental pollutants from classrooms.

Ceiling-Mounted Exhaust/Return Vent

1. Repair univents/thermostats in classrooms 107, 231 and 233 to reduce heat.
2. Inspect exhaust motors and belts for proper function, repair and replace as necessary.

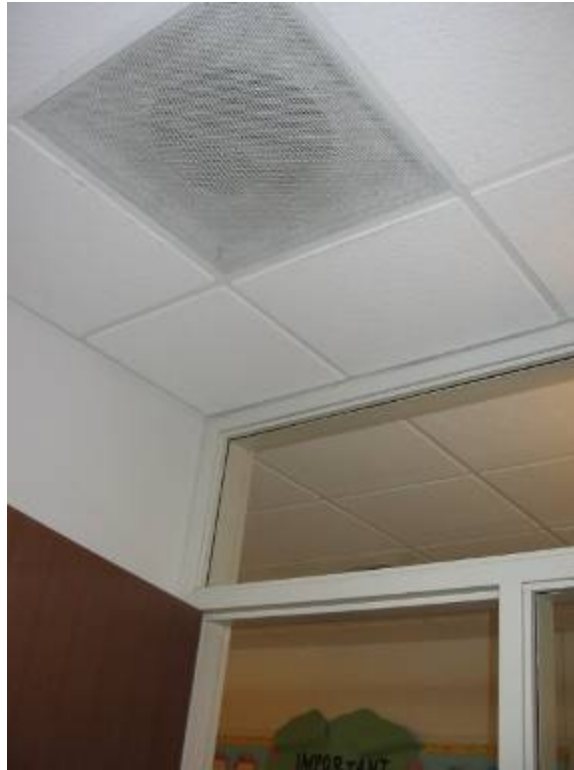
Picture 5

Classroom Exhaust Vent Located Above Door

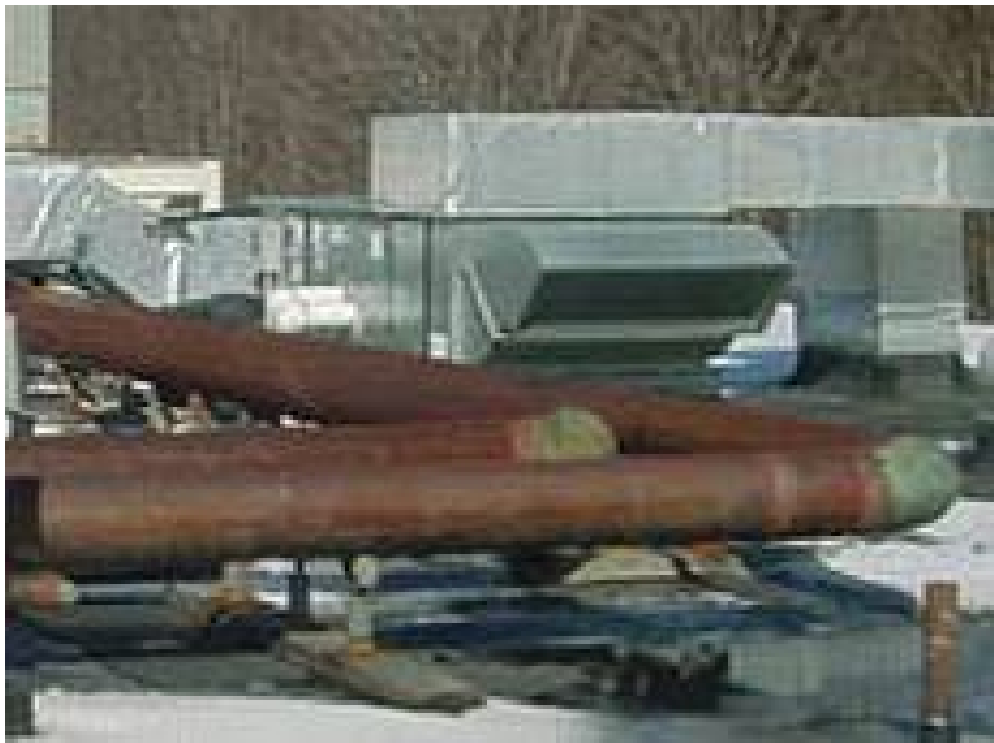
Picture 6

Mechanical ventilation for interior rooms and common areas (e.g., offices, library, gym) is provided by rooftop air-handling units (AHUs) (Picture 6). Fresh air is ducted to classrooms via ceiling-mounted fresh air diffusers (Picture 7). Exhaust air is drawn through ceiling-mounted vents and ducted back to the AHUs (Picture 7). These systems were functioning during the assessment.

Rooftop Air Handling Unit

7. Consider adopting a balancing schedule for mechanical ventilation systems every 5 years, as recommended by ventilation industrial standards (SMACNA, 1994).

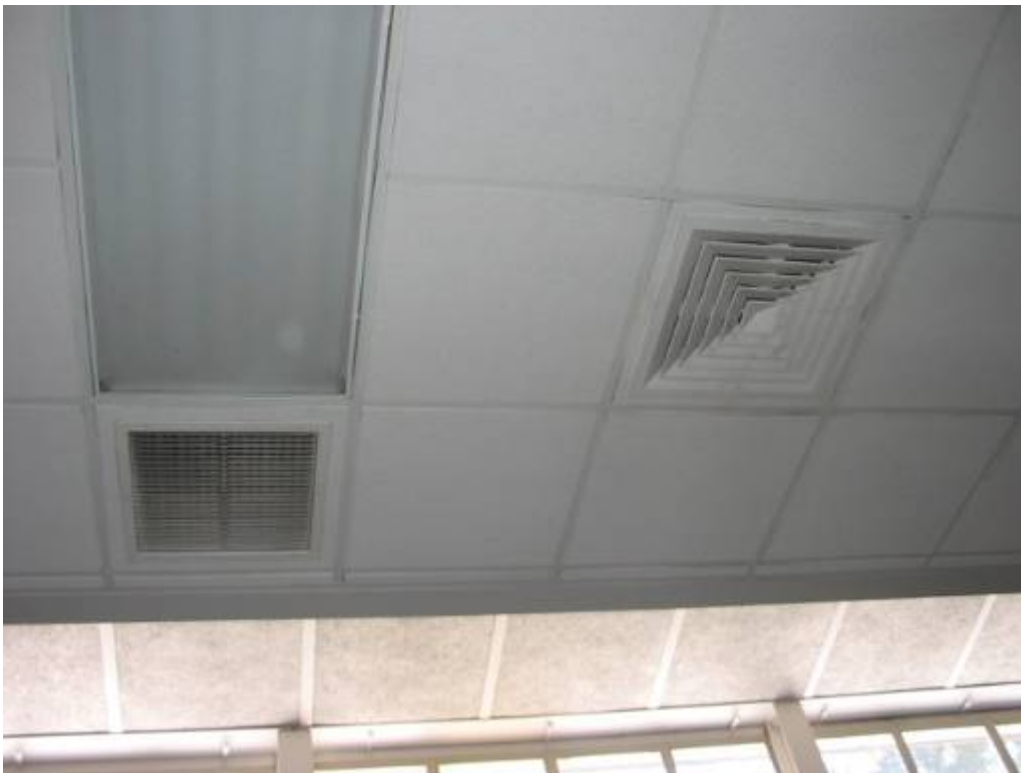
Picture 7

Ceiling-Mounted Supply Air Diffuser (Right) and Return Vent (Left)

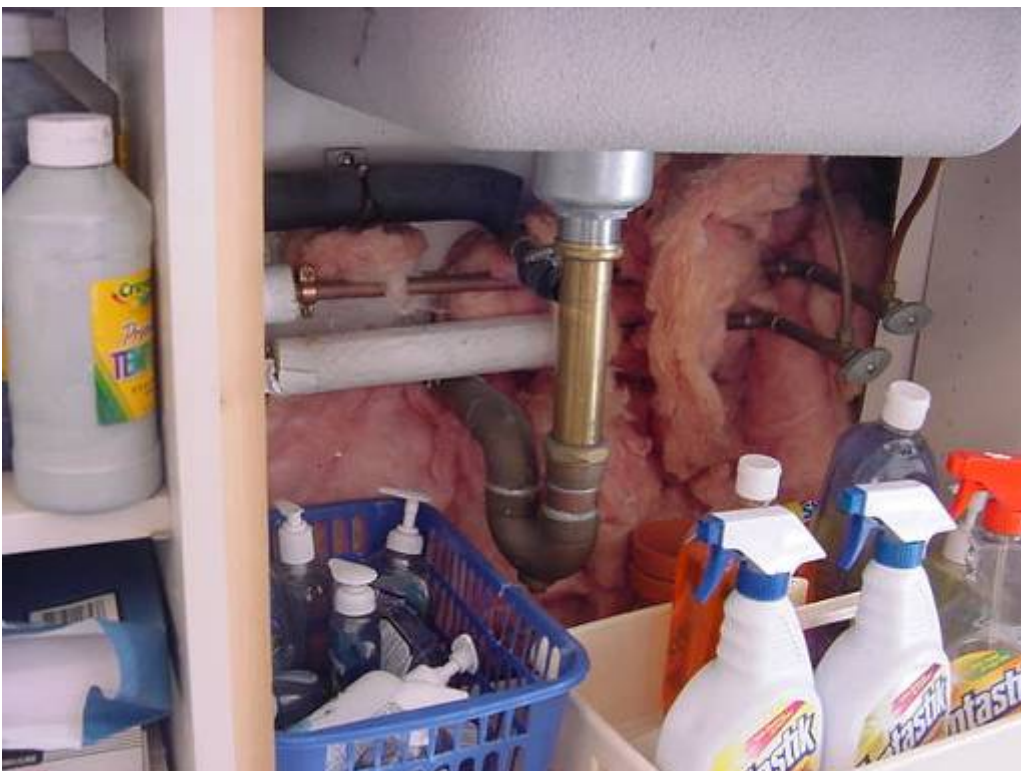
Picture 8

It was reported that a leak occurred two years prior to the MDPH assessment due to a frozen pipe between classrooms 106 and 107. To prevent a reoccurrence, pipes were replaced and the wall cavity was insulated with fiberglass (Picture 8). Moisture measurements were taken in this area and it was determined that GW had low (i.e., normal) moisture content at the time of the assessment. However, vinyl base coving was removed and a dark staining which appeared to be mold was identified along GW baseboard (Picture 9). GW is a porous material that absorbs moisture; the vinyl coving acts as a barrier and “traps” moisture behind it, which can create conditions for mold growth. At the time of the assessment it was recommended by CEH staff that the section of GW be replaced (At the time of this report preparation it is unknown whether this action was taken).

Exposed fiberglass insulation was observed between rooms 106 and 107 (Picture 8). As mentioned previously, this area was insulated to prevent the freezing of pipes. If work has been completed, this area should be sealed. Fiberglass insulation can provide a source of skin, eye and respiratory irritation.

Wall Cavity between Classrooms 106 and 107 Insulated With Fiberglass

14. Seal holes between rooms 106 and 107 to prevent exposure to fiberglass insulation.
15. Consider adopting the US EPA document, *Tools for Schools* (US EPA, 2000), as a means to maintaining a good indoor air quality environment in the building. This document can be downloaded from the Internet at <http://www.epa.gov/iaq/schools/index.html>.

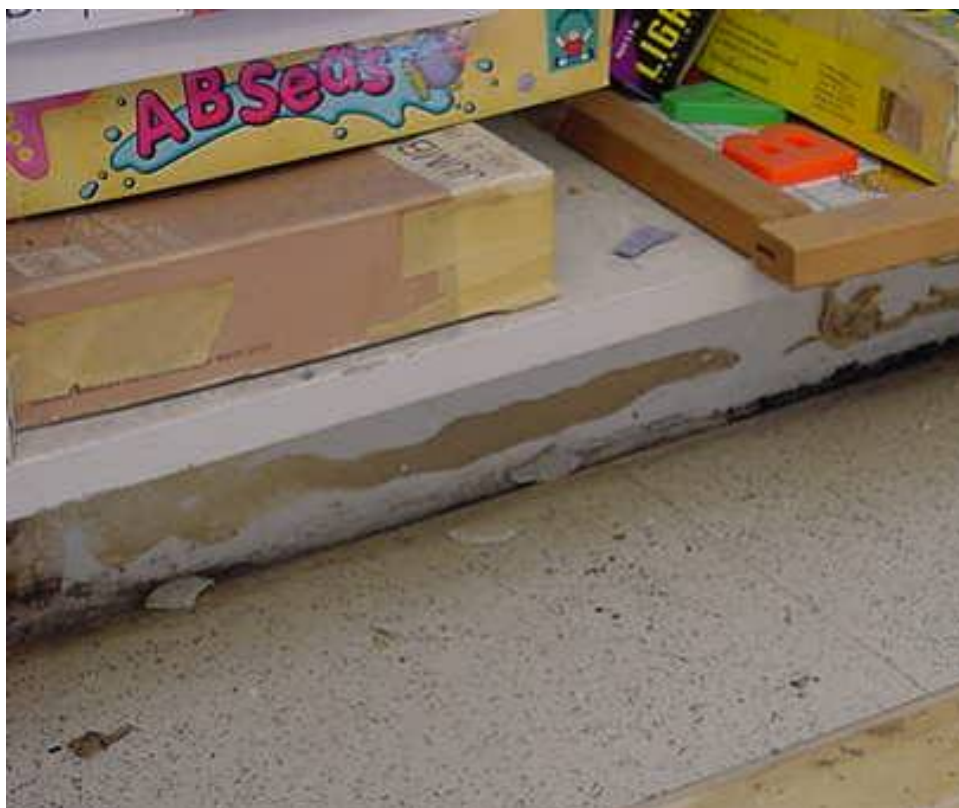
Picture 9

Dark Staining Indicating Possible Mold Growth along GW Baseboard in Room 106

| Location/ Room | Occupants in Room | Temp (°F) | Relative Humidity (%) | Carbon Dioxide (ppm) | Carbon Monoxide (ppm) | TVOCs (ppm) | PM2.5 (µg/m3) | Windows Openable | Ventilation | | Remarks |
|---|---|---|---|---|---|---|---|---|---|---|---|
| 106 | 0 | 77 | 12 | 615 | ND | ND | 8 | Y | Y univent | Y ceiling | Univent obstructed with furniture, gypsum wallboard-low (i.e., normal) moisture, dark staining behind vinyl coving indicating possible mold growth-rec. removal |

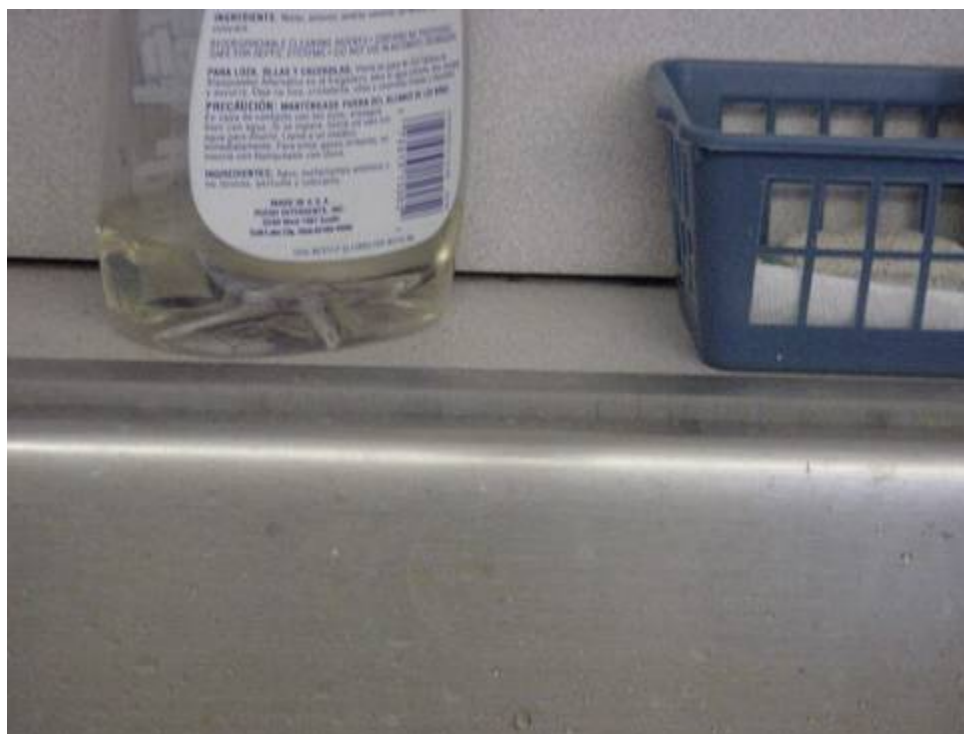
Picture 10

Breaches were observed between the counter and sink backsplashes in some classrooms (Picture 10). If not watertight, water can penetrate through these seams. Water penetration and chronic exposure of porous and wood-based materials can cause these materials to swell and show signs of water damage, which can subsequently lead to mold growth.

Spaces between Sink Countertop and Backsplash

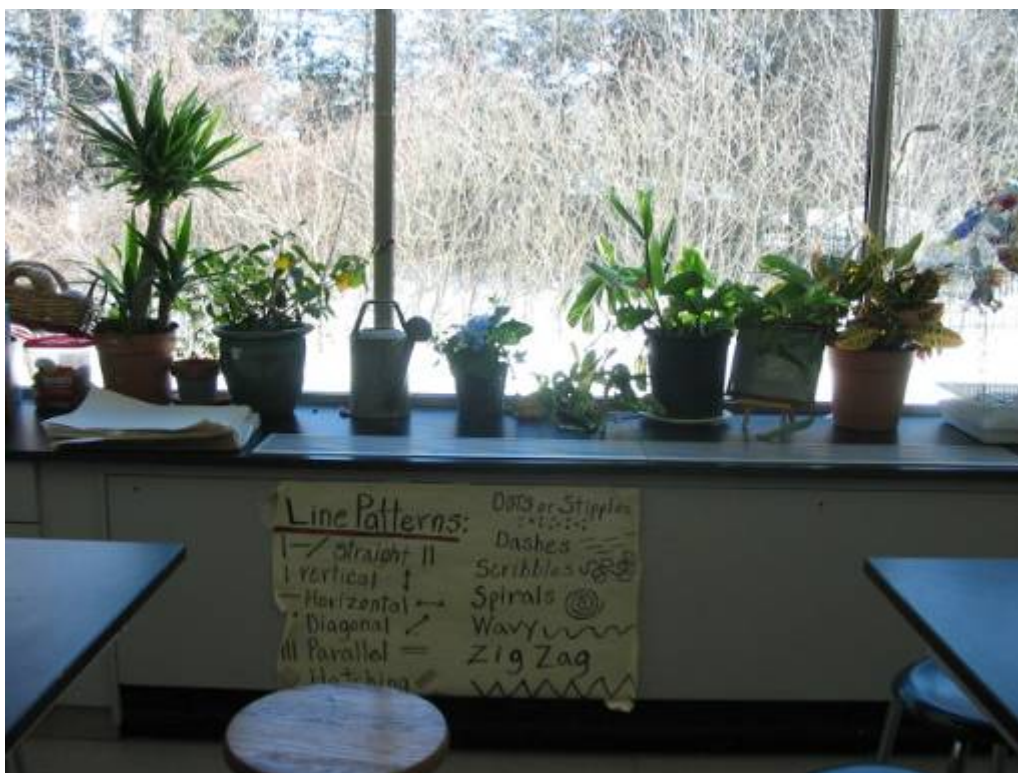
Picture 11

Plants were noted in several classrooms. Some plants were observed on univents (Picture 11) Plants can be a source of pollen and mold, which can be respiratory irritants for some individuals. Plants should be properly maintained and equipped with drip pans. Plants should also be located away from ventilation sources (e.g., univent air diffusers) to prevent the entrainment and/or aerosolization of dirt, pollen or mold.

Plants Located on Univents

9. Ensure plants have drip pans. Examine drip pans periodically for mold growth and disinfect with an appropriate antimicrobial where necessary. Remove plants from the air stream of univents.

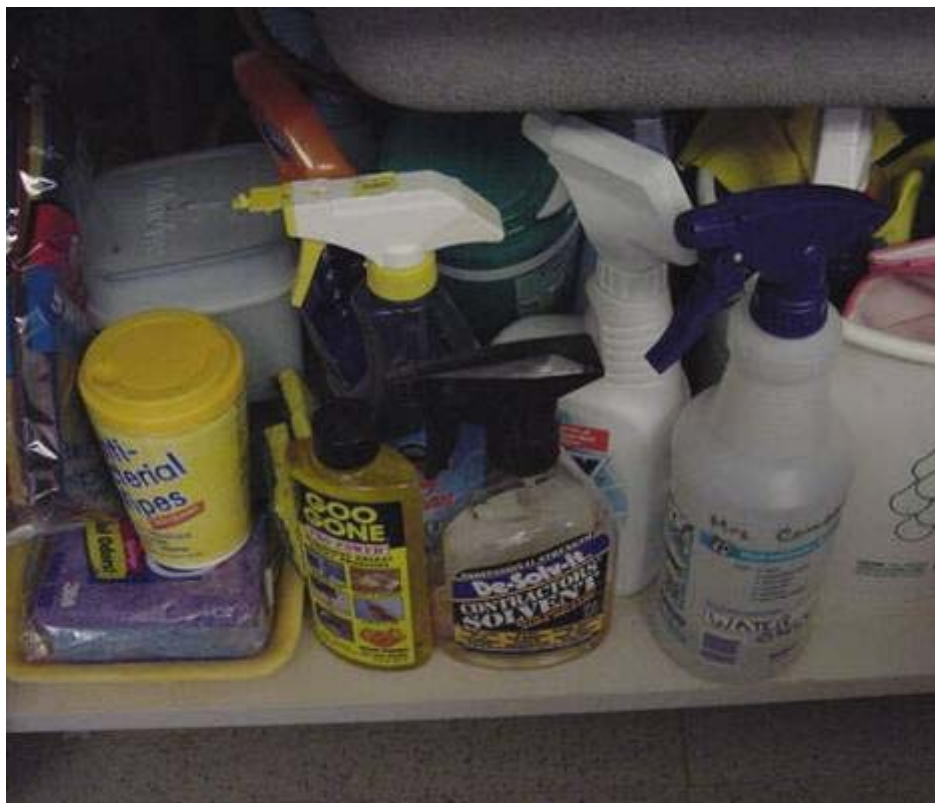
Picture 12

Cleaning products and solvents were found on countertops and in unlocked cabinets beneath sinks in some classrooms (Picture 12). Like dry erase materials, cleaning products contain VOCs and other chemicals that can be irritating to the eyes, nose and throat of sensitive individuals. Plug-in type air fresheners and spray air deodorizers were also

Spray Cleaning Products and Solvents under Sink in Classroom

10. Store cleaning products properly and out of reach of students. Ensure spray bottles are properly labeled. *All* cleaning products used at the facility should be approved by the school department with MSDS' available at a central location.

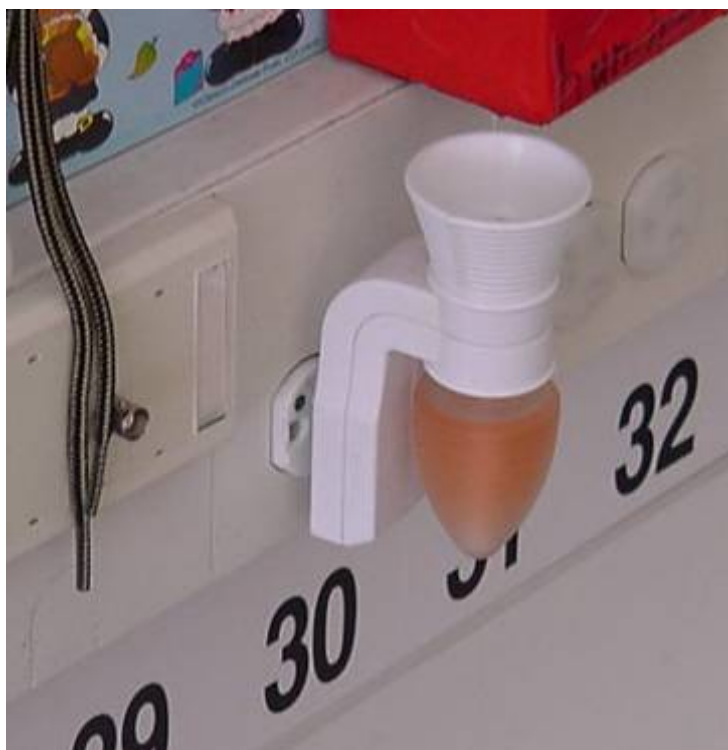
Picture 13

observed in several classrooms (Pictures 13 and 14). Air fresheners and deodorizers contain chemicals that can be irritating to the eyes, nose and throat of sensitive individuals. Furthermore, air fresheners and deodorizers do not remove materials causing odors, but rather mask odors that may be present in the area.

Plug-in Air Freshener in Classroom

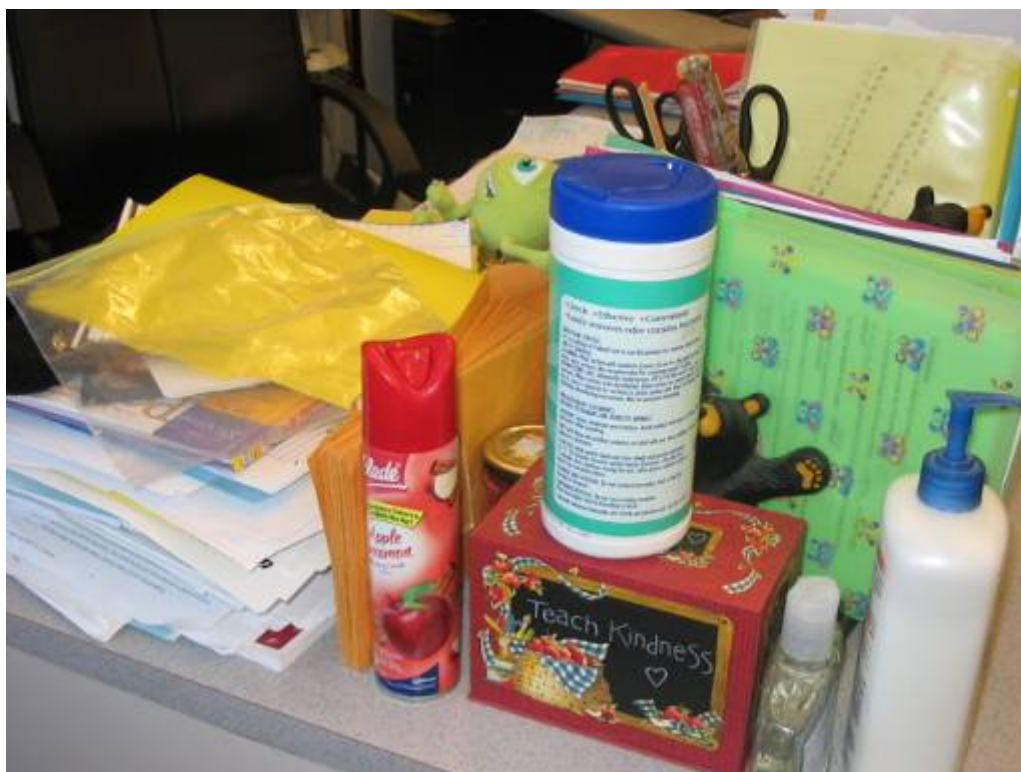
Picture 14

Spray Air Deodorizer

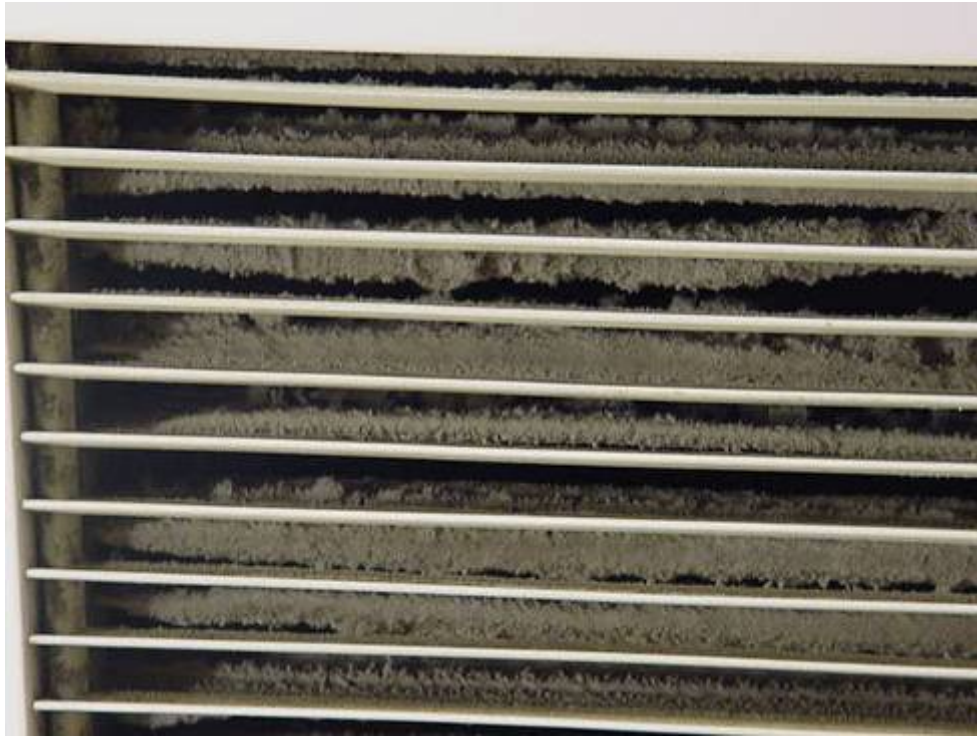
Picture 15

Other conditions that can affect indoor air quality were observed during the assessment. Several personal fans and ceiling-mounted exhaust vents were occluded with dust (Pictures 15 and 16). Dust can be a source for eye and respiratory irritation. If exhaust vents are not functioning, backdrafting can occur and aerosolize dust particles. Re-activated personal fans can serve to distribute dust.

Dust Build-up on Exhaust Vent

12. Clean exhaust/return vents and personal fans of accumulated dust periodically to prevent the aerosolization of dirt, dust and particulates.
13. Consider relocating personal cooking appliances to a central location to prevent pests/rodents.

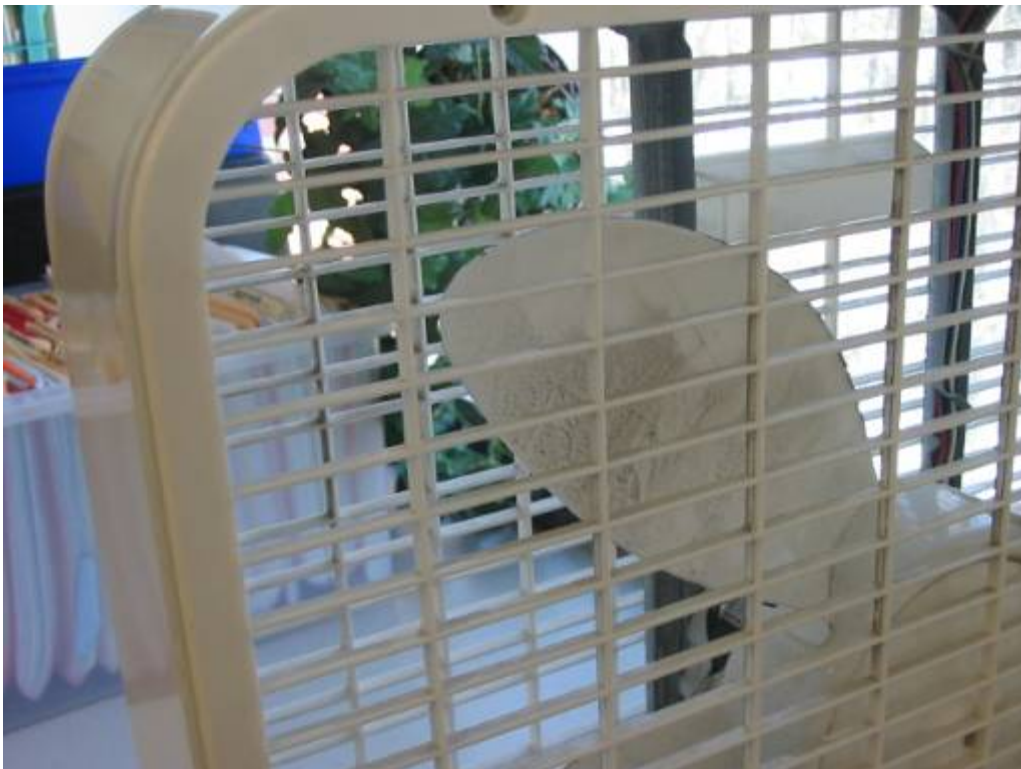
Picture 16

Dust Build-up on Personal Fan

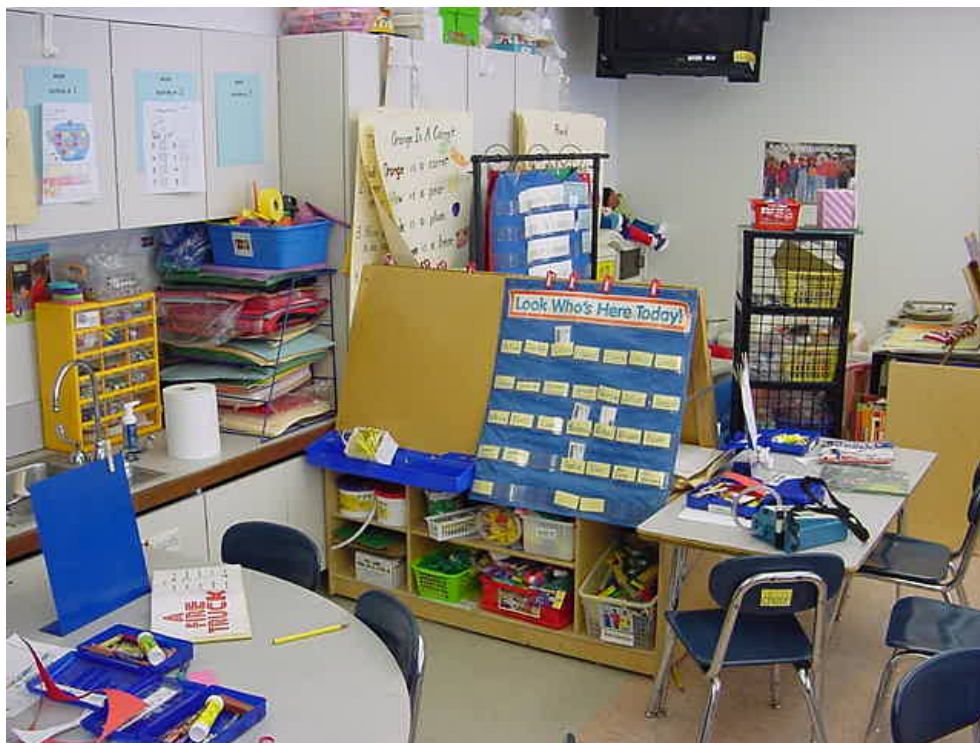
Picture 17

Also of note was the amount of materials stored inside classrooms (Picture 17). In some classrooms items were observed on windowsills, tabletops, counters, univents, bookcases and desks. The stored materials in classrooms provide surfaces for dust to accumulate. Accumulation of these items (e.g., papers, folders, boxes) makes cleaning difficult for custodial staff.

Accumulated Items in Classroom

11. Relocate or consider reducing the amount of materials stored in classrooms to allow for more thorough cleaning. Clean items regularly with a wet cloth or sponge to prevent excessive dust build-up.
